Review of emergency shelter solutions in Haiti

Joseph Ashmore

May 2010

This is a technical evaluation of emergency shelter solutions found in Haiti four months after the earthquake of January 12th. It focuses on items that provide the structure and the covering of shelters.

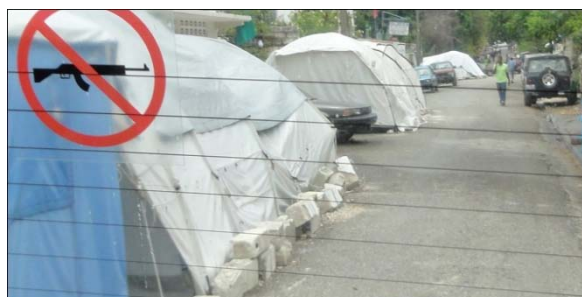
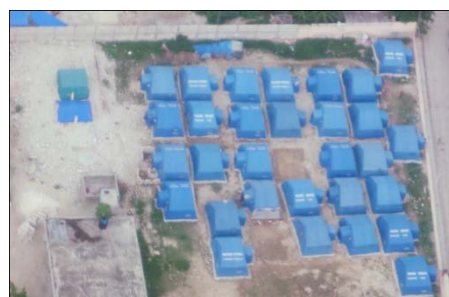
Tents have been used in locations where transitional shelters could not be built such as on roadsides in front of people's houses (left) or in planned camps (right) which have to be built quickly

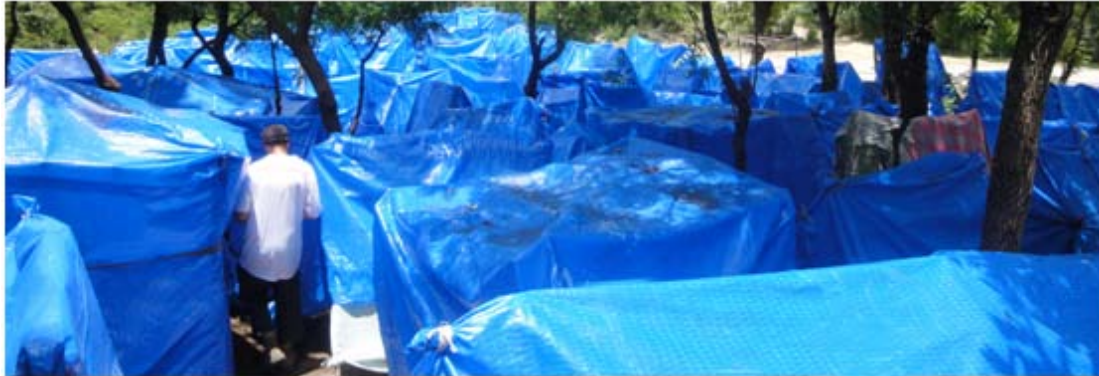
Example of a fake shelter site - this site was unoccupied but placed so that recipients could qualify for relief distributions.

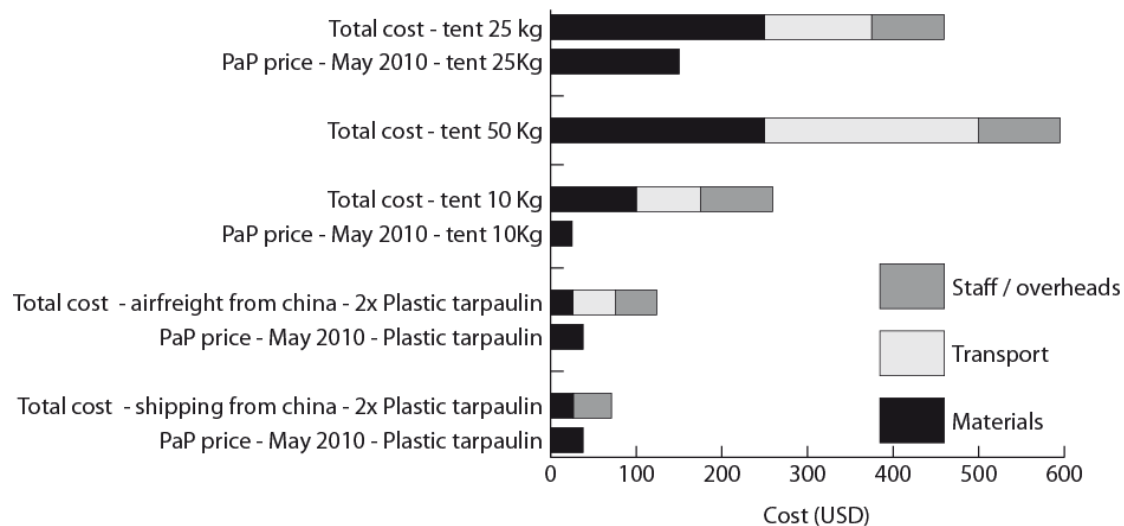
Graph 1: Illustration of the cost of delivery of materials for one household – Staff / overheads costs based on actual budget data from an NGO, and include all related components of an emergency distribution programme. It does not take into account the household items that were distributed alongside the tents/tarpaulins. Transportation costs are based on air transportation from China.

The actual cost to deliver items to families is often in excess of the cost of the materials themselves (see graph 1).

Using air freight to transport a tent or a tarpaulin can more than double its cost. Adding the programmatic costs of delivery (including staff, accommodation, vehicles, support for registration, distribution, training and follow up monitoring) will add to the total cost of the materials. As a result, a tent that costs 250 USD at the factory door may cost in excess of 500 USD to deliver. This does not include the opportunity costs of delivering to meet needs in a limited timeframe, and the need to distribute additional tarpaulin at a later stage to waterproof leaky tents.

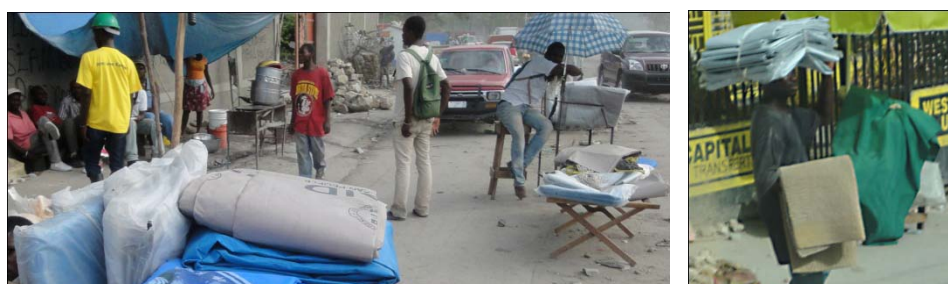
A market exists in second hand plastic sheeting. Left: a street market, right: a street hawker

Following distributions, markets have emerged in the resale of tents and tarpaulins. Tarpaulins can be found on street side stalls or sold by street hawkers purchasing them and then reselling them for a 30% mark up. It also appears that there is a trade, purchasing tents in Jacmel and transporting them to Port au Prince for resale.

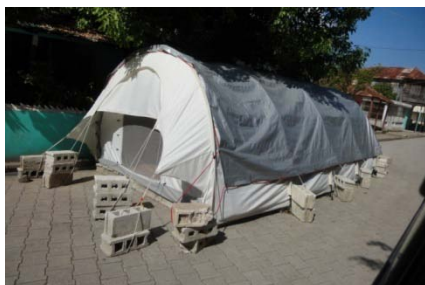
5.2 18m² tunnel tent

Description: These tents are generally of a good specification from major international organisations. They have flexible poles (usually fibreglass) and a fly sheet with an inner liner.

Lifetime: After less than four months many of these tents were still standing. However, the majority were covered in tarpaulins because they leaked. Some of the fabric was seen to pull where the stitching was under stress

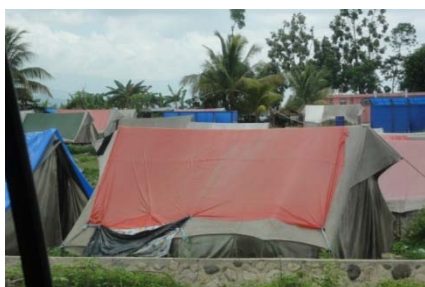
5.3 canvas ridge tent

Description: Traditional canvas tents. Some have higher walls than others, and these ones were preferred

Lifetime: The key issue with these tents was quality. Many were poorly rot-proofed and were dark with mildew after only a few months, limiting their lifetime.

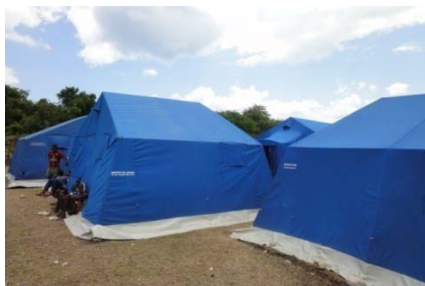
5.4 Frame tent

Description: Frame tents with heavy duty canvas covering. The samples observed were generally of high quality, and heavy (and hence expensive to airfreight), coming from national emergency stockpiles from Europe.

Lifetime: As a result of the quality of these tents, it is expected that they will last over one year.

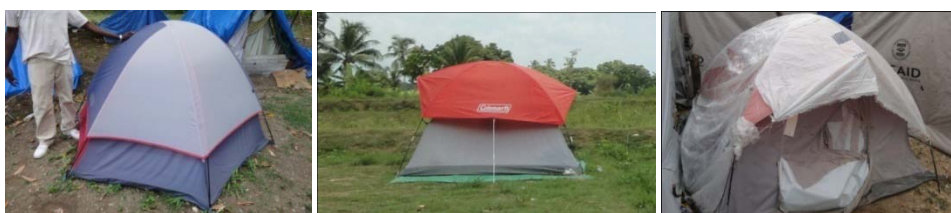
5.6 Small hike tents

Description: Tents designed marketed for the hiking markets.

Lifetime: Dependent upon the quality between 15 days and 6 months

Comments: People said that these were only used for sleeping in for a few days but were generally too small. For some the quality was very bad and they had already broken.

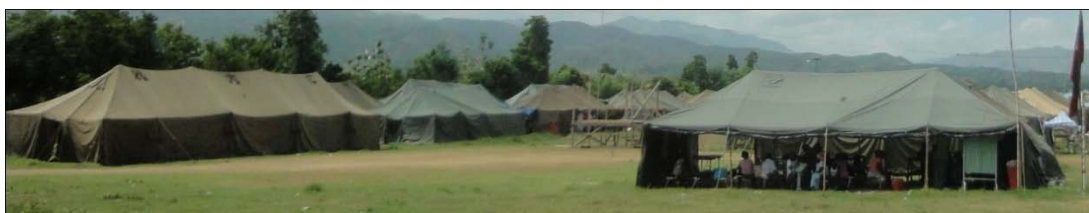
5.7 Marquees and multi-family tents

Description: Large tents – often ex military used for collective shelter. Many later re-used for temporary classrooms.

Lifetime: Long lifetime, though require maintenance, as there is a risk of pegs pulling out.

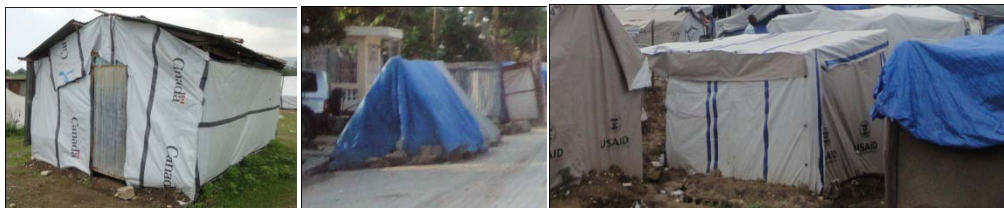
Examples of shelters build with plastic sheeting. Left and right: “box frame”; centre: “A frame”

The majority of shelters built since the earthquake using plastic sheeting have a box frame, consisting of poles embedded in the corners and in some cases horizontal poles connecting the corners of the shelter. A small minority are made using an A frame structure (see photo above). Commonly 12 poles are used for a shelter. The quality of the structures is highly dependent upon the amount of timber that the family has been able to find or purchase. Some of them use string between vertical poles (instead of timbers) to hold the roof sheet up.

The largest challenge with the use plastic sheeting is that it is often not fixed tight so that it flaps with the wind. It is often stretched over sharp sticks or sharp corners of the structure so that it is more likely to rupture and leak.

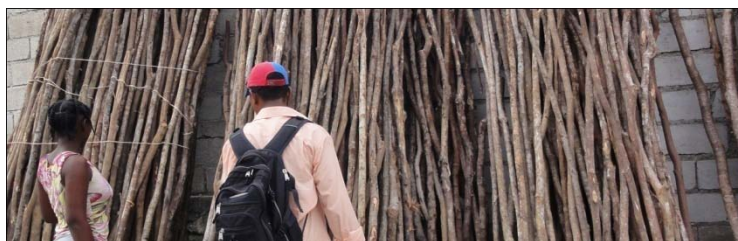
The distribution of tarpaulins undoubtedly lead to large numbers of trees being cut. Surveys by the Rapid Environmental Assessment team³ noted that the timber is often sourced locally. The increase in demand is highlighted by the costs of timber poles doubling since the earthquake.

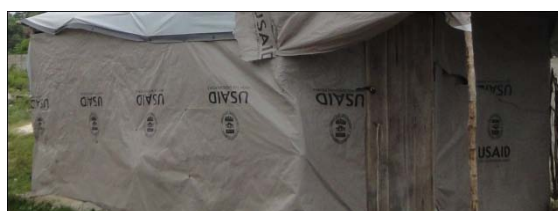
6.1 USAID SPECIFICATION

This was the most popular type of plastic sheeting

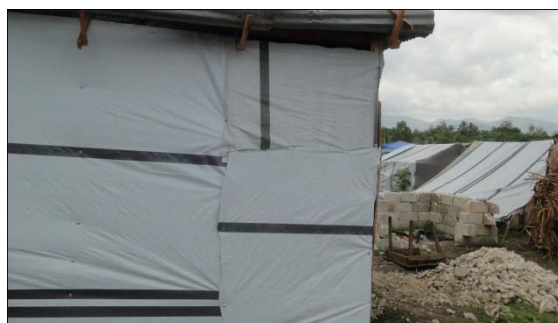
6.2 White with grey stripes

This is woven polyethylene sheeting with a black core, and white laminations.

Note there were several varieties with the same colouration, but of inferior composition.

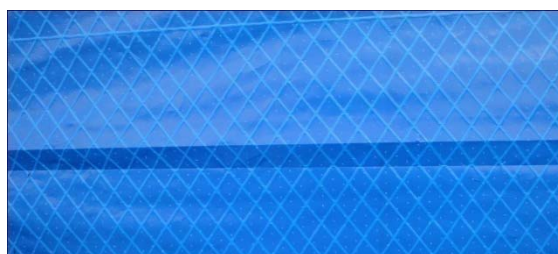
6.3 Braided / laminated - without black core (blue)

Braided plastic sheeting blue and slightly translucent

Families said that this type of sheeting made shelters hotter than other shelters and let light through, reducing privacy.

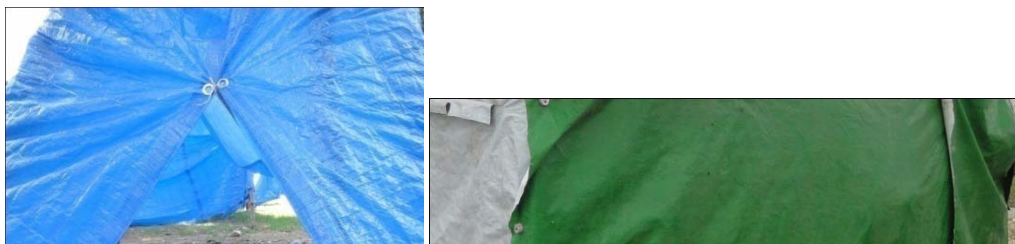
6.4 Other specifications

Many different specifications of plastic sheet can be observed on shelters and in the markets. Those illustrated above are both woven, but with are relatively light weight and decay rapidly in the strong sunlight of Haiti.

The majority of poor quality sheets were distributed by external organisations rather than imported by traders. One major donation of more than 10 containers from a major donor was of substandard plastic sheeting, and organisations distributed informing families that it should not be used for roofing as it would leak.
